# Application Report JL French

JL French

Eddy Current inspection of aluminium six cylinder with steel sleeve inserts. Manual inspection preferred with ease of use and semi fast throughput capabilities.

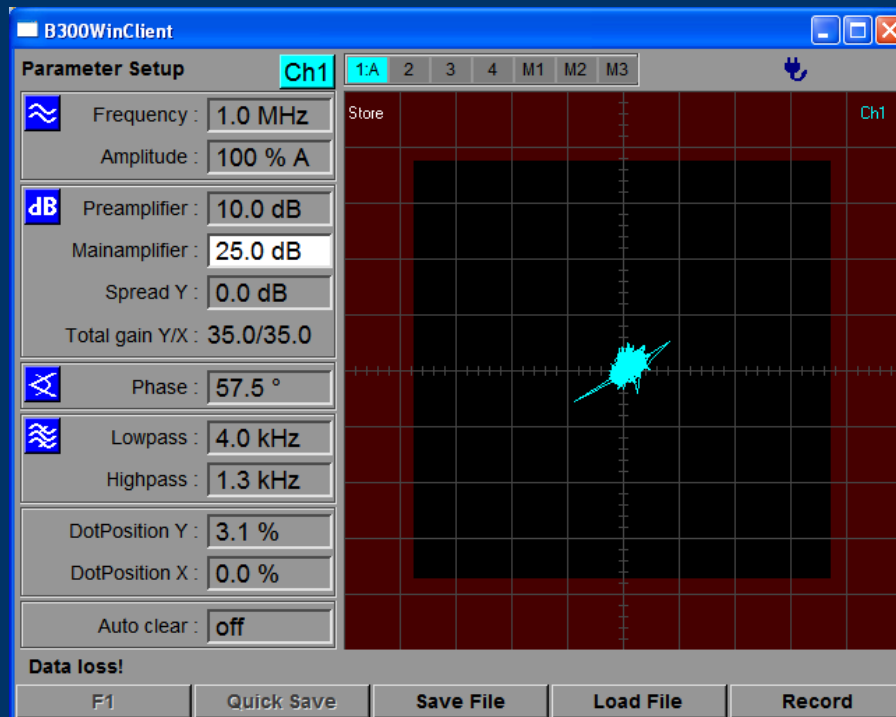
## Finished Block Sleeve #1

No defect located

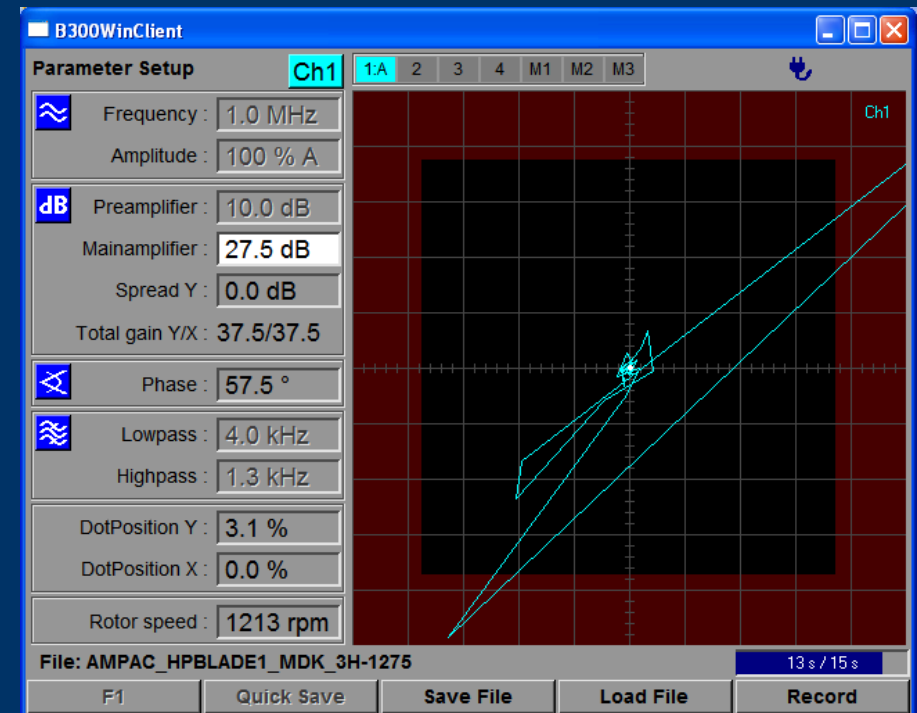
## Finished Block Sleeve #2

Defect located: marked defect near the bottom of sleeve

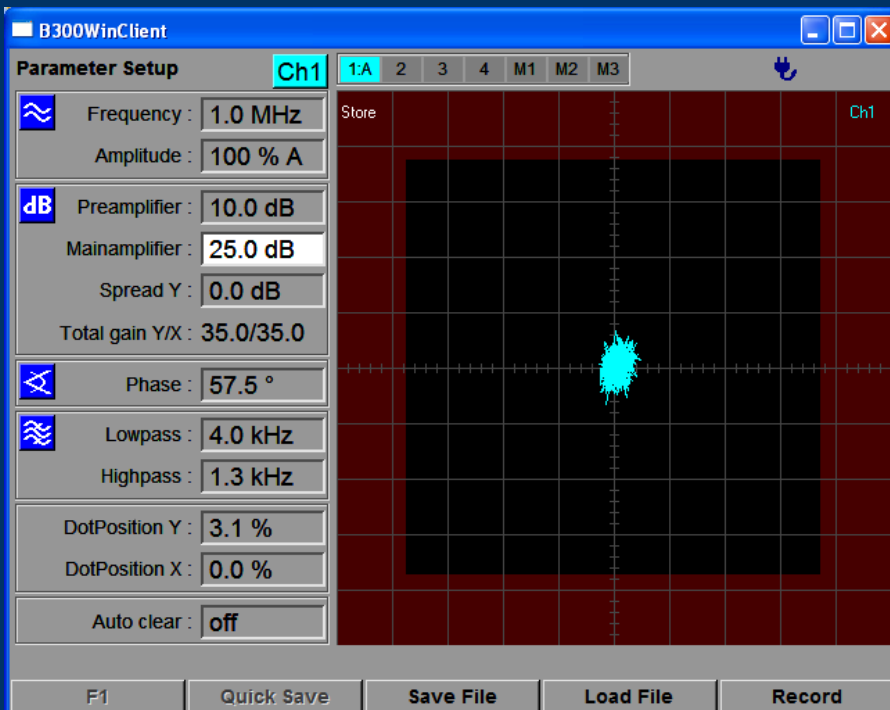
## Finished Block Sleeve #3

No defect located

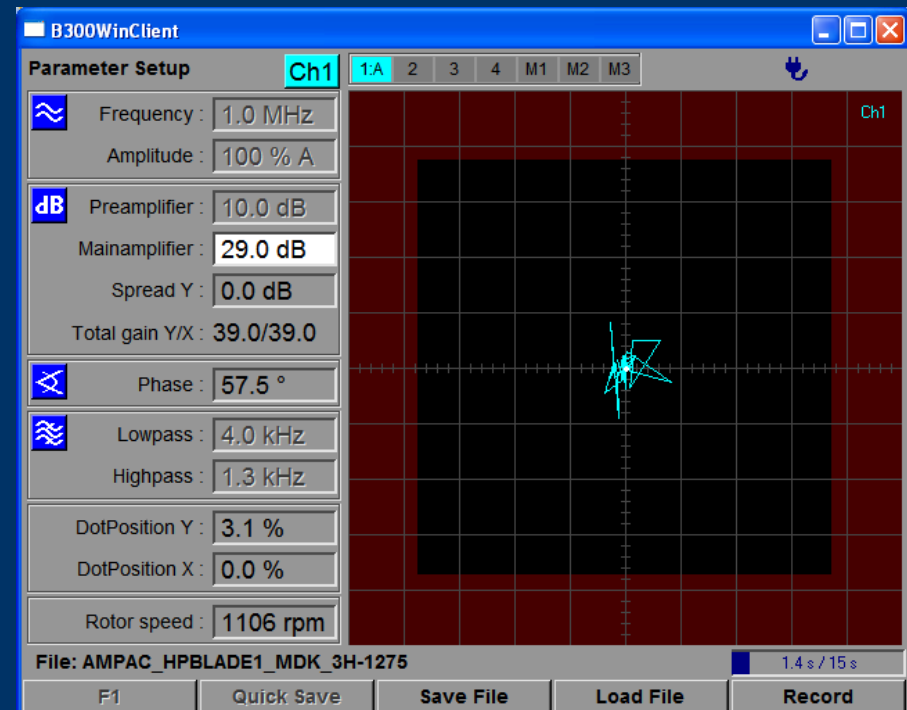
## Finished Block Sleeve #4

No defect located

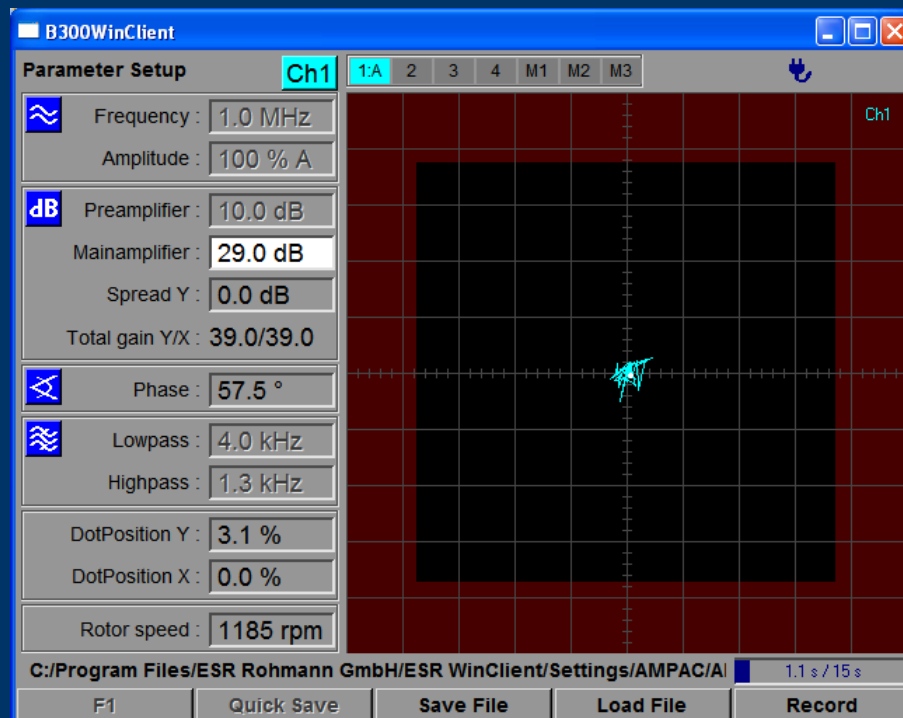
## Finished Block Sleeve #5

No defect located

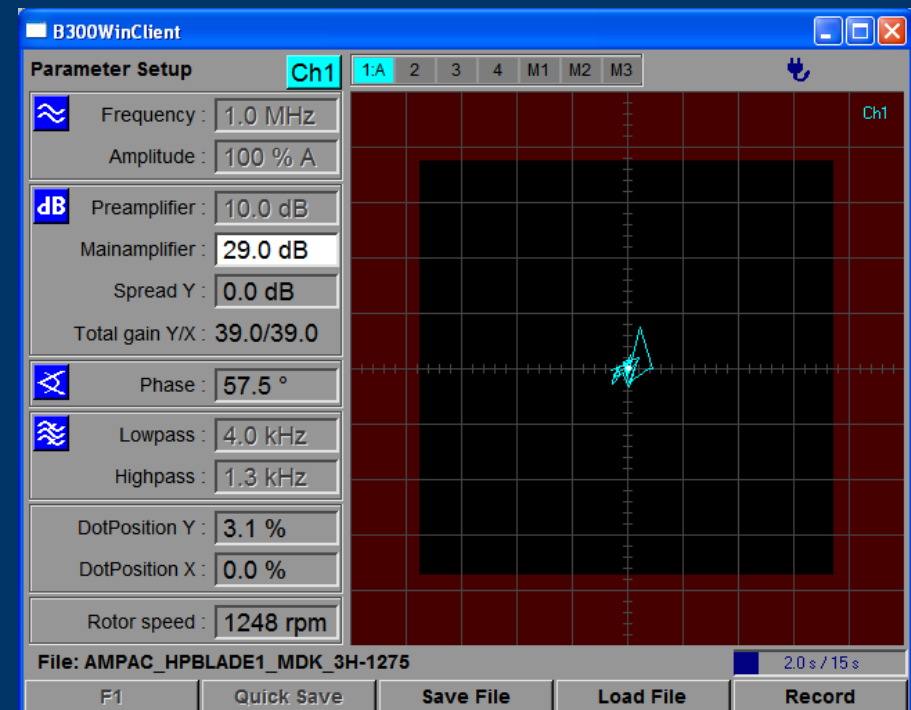
## Finished Block Sleeve #6

No defect located

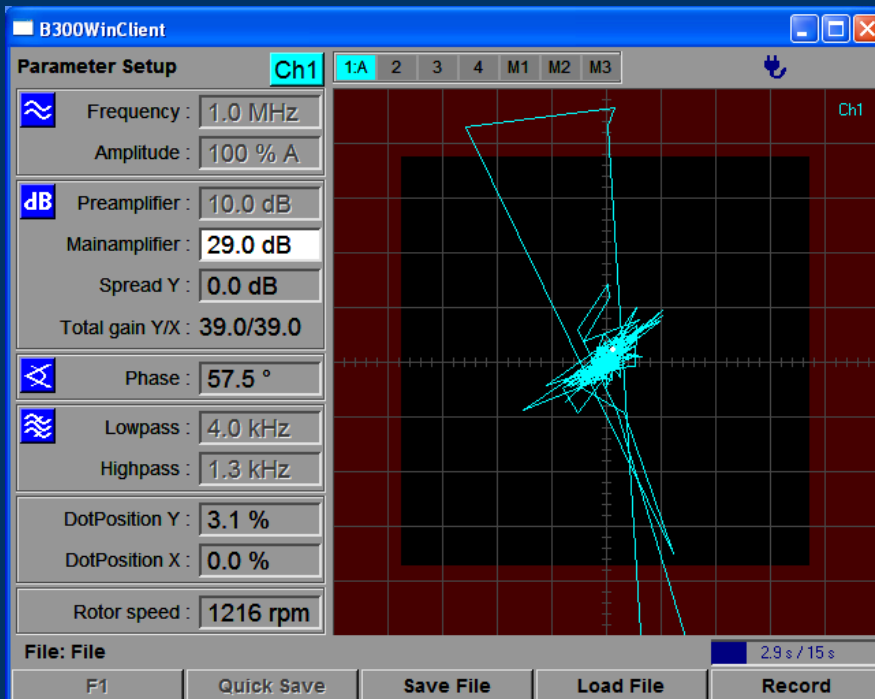
## Non Finished Block Sleeve #7

No defect marked, but internal flash not removed creates a false reject (signal results from noise/flash)

The first two engine blocks that were sent in that were not honed out completely were not feasible for EC inspection. You will find that if you try and inspect in this non finished state you would be rejecting approx 60-70% false rejects due to aluminium flash on the internal wall of the sleeves.

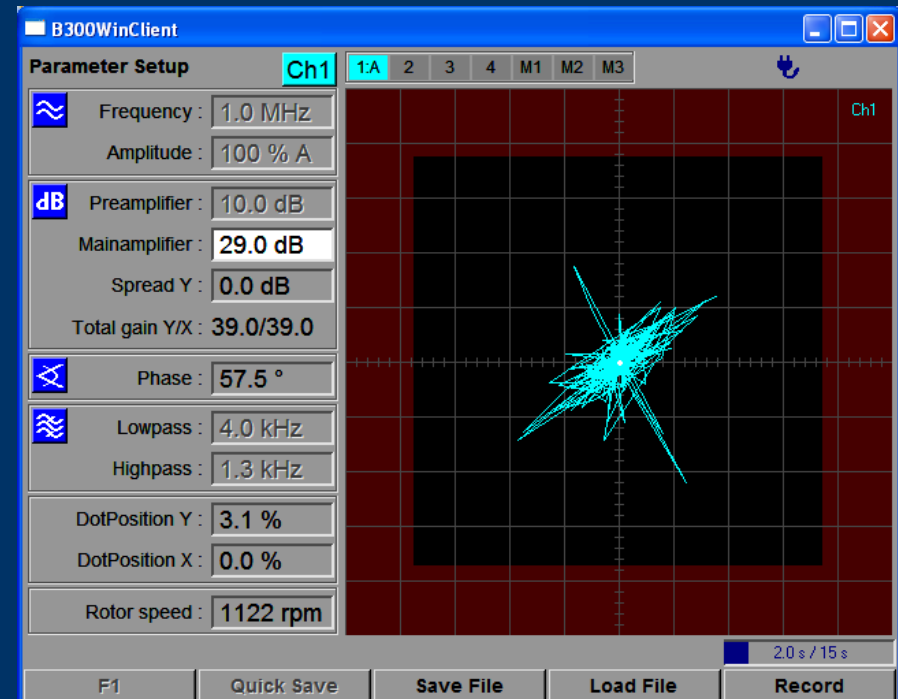
## Non Finished Block Sleeve #8

Defect Located: Marked area with known defect located at bottom of sleeve.  
Amplitude of signal is not as large as Sleeve #7, which is a clear sign this stage of the block is not clean enough to inspect in

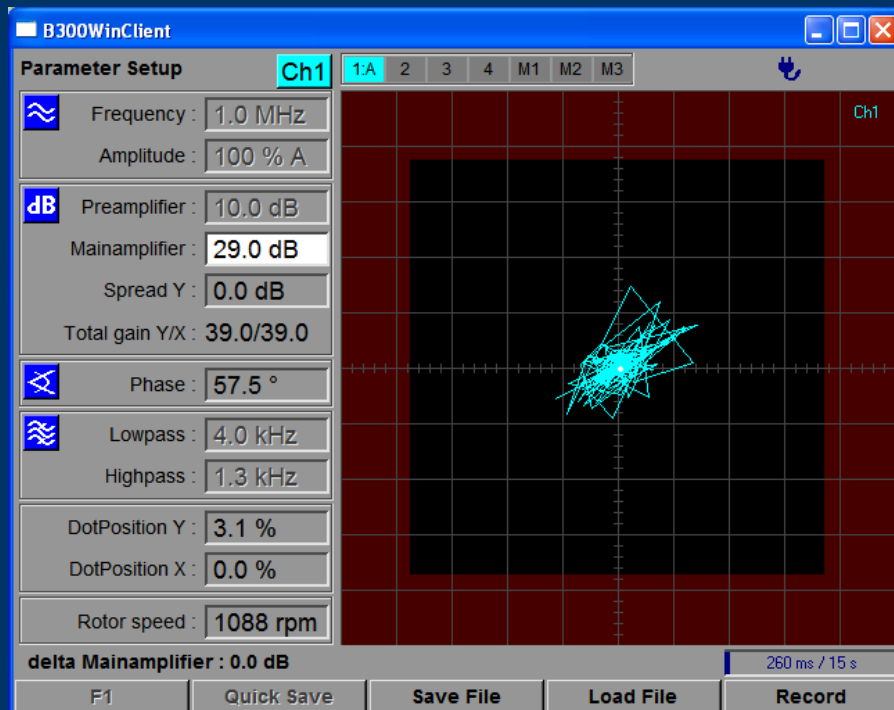
## Non Finished Block Sleeve #9

No defect located (signal results from noise/flash)

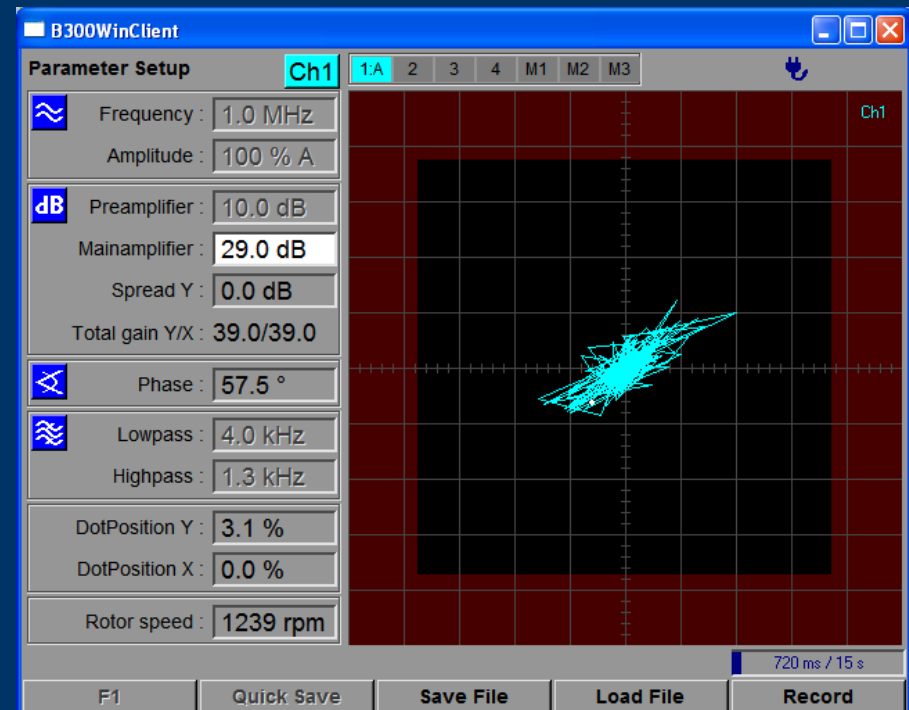
## Non Finished Block Sleeve #10

No defect located (signal results from noise/flash)

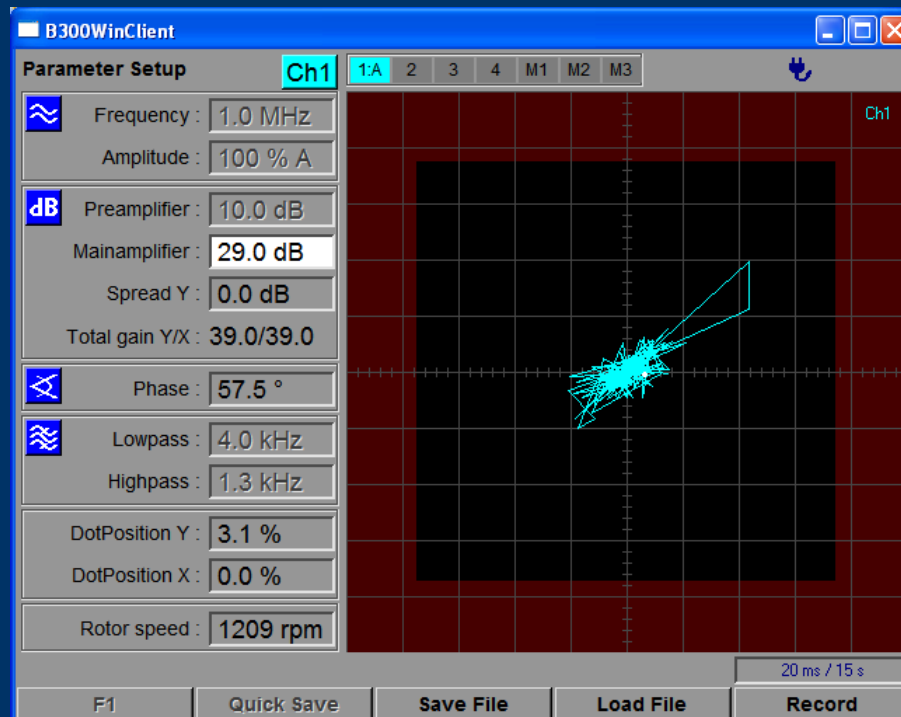
## Non Finished Block Sleeve #11

No defect (signal results from noise/flash)

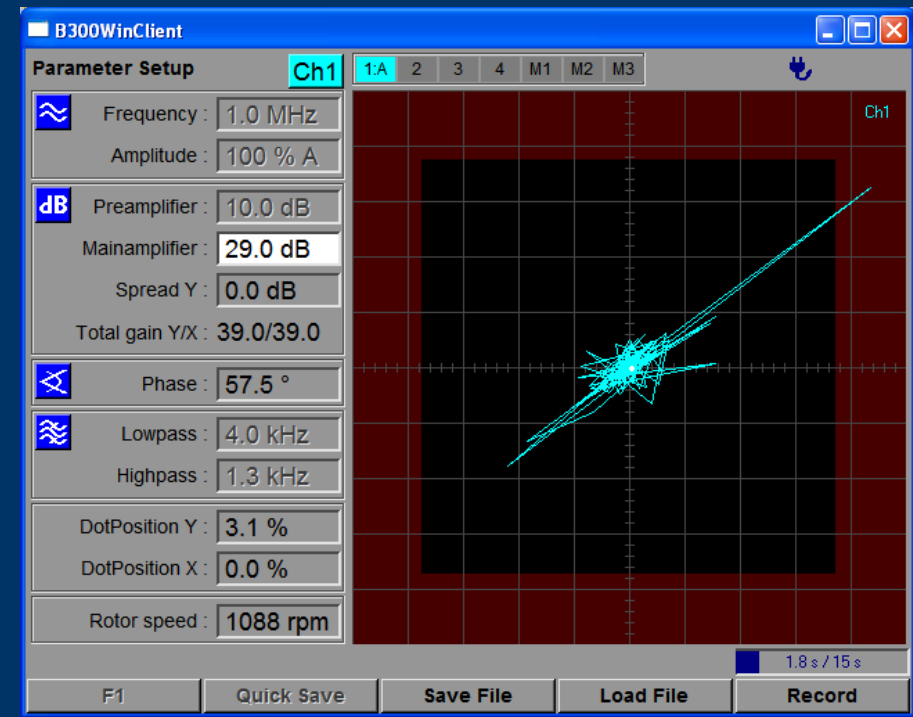
## Non Finished Block Sleeve #12

No defect (signal results from noise/flash)
